Site Survey of Selected Items
for
Compliance with the Americans with Disabilities Act
(ADAAG)
and
Title 24 of the CBC

The site survey of Peary Middle School was conducted on November 30, 2006 during a spot check for compliance with the Americans with Disabilities Act Guidelines (ADAAG) and Title 24 of the CBC

Facility Name: Robert Peary Middle School

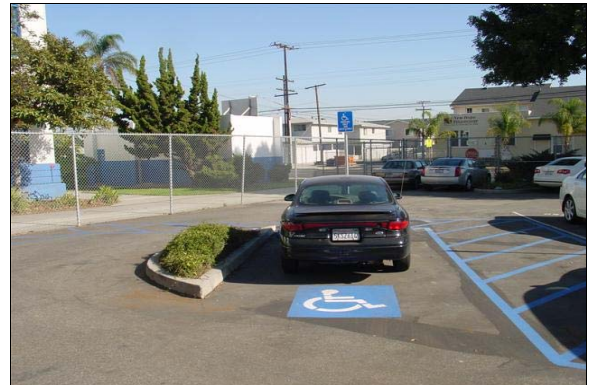
Accessible Parking

Finding: The van-accessible space is not outlined on the left.

Full Rec Restripe the existing van-accessible parking space on both sides so it measures at least 108 inches wide and 216 inches long with an

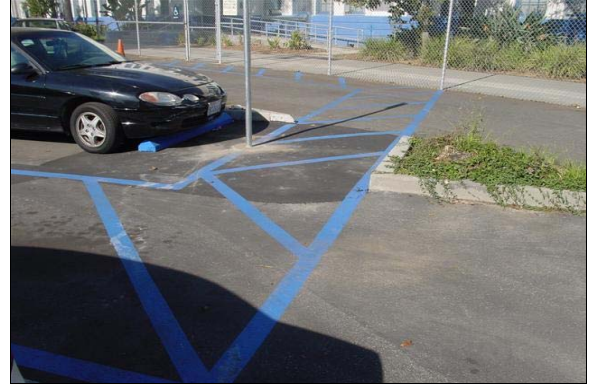
Accessible Parking

Finding: There is a crosswalk provided on the path of travel from the accessible parking to the facility, the crosswalk does not provide detectable warnings at the entrance and exit of the crosswalk.

Full Rec Install a detectable warning surface at the entrance and exit of the crosswalk with truncated domes that contrast visually by either light on dark or dark on light which is an integral part of the concrete curb ramp. The truncated domes may be cast in place or stamped or of a prefabricated surface treatment (see CBC 1127B.5.8).

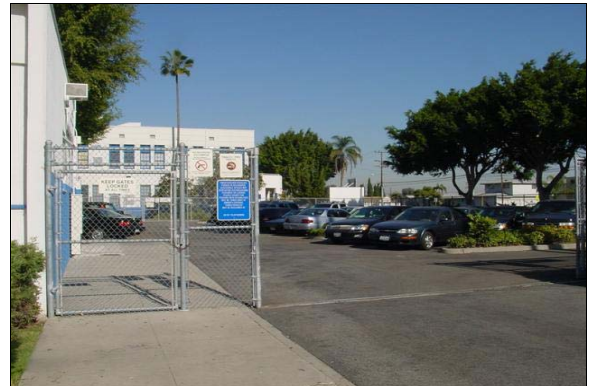
Accessible Parking

Finding: There is warning signage posted at the entrance to the parking lot off of Gardena Boulevard. The point of contact and telephone number for reclaiming towed vehicles have been left blank. The sign does not contain the California Vehicle Code 22511.8(a)(d).

Full Rec Fill in the blank spaces which are required to furnish the point of contact and telephone number for reclaiming towed vehicles with the appropriate information as a permanent part of the sign and maintain the currency of the information (see CBC 1129B.5). Make sure to add the CVC22511.8(a)(d) to the sign.

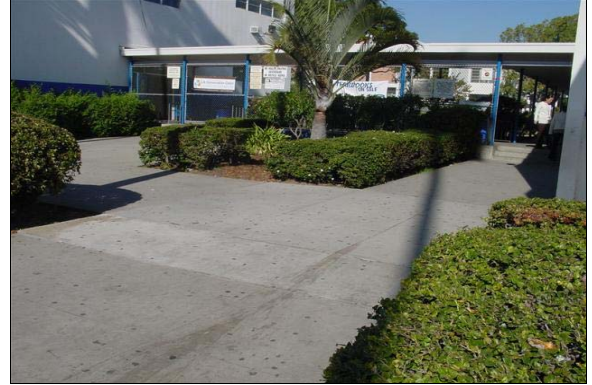
Accessible Route from the Public Right of Way

Finding: There is stair access only to the entrance of the facility. There is no directional signage to the main entrance.

Full Rec Provide at least one accessible route from the public right of way to the accessible entrance of the facility. Make certain to post signage indicating the direction to accessible building entrances at every major junction along the accessible route. Signs shall include the International Symbol of Accessibility. A ramp or other means of vertical access is required.

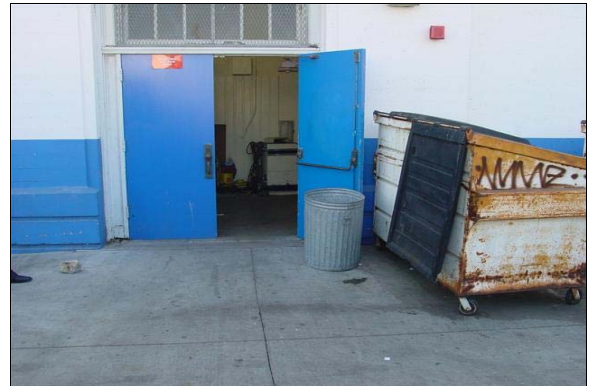
Accessible Route to the Home Economics Restrooms

Finding: There are cross slopes greater than 2% on the accessible route to the restrooms in the Home Economics Building

Full Rec Resurface the path of travel to provide a level surface that does not exceed a slope greater than 5%. Cross slopes shall not exceed 2%.

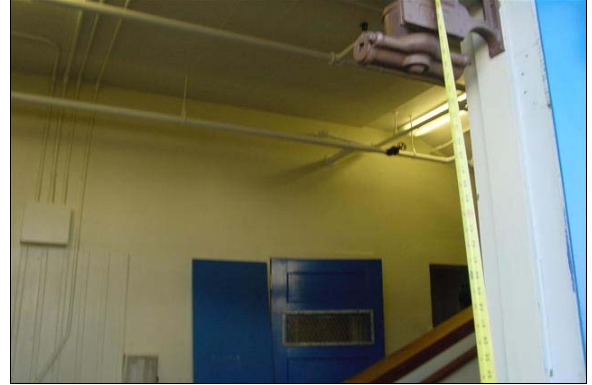
Accessible Route to the Home Economics Restrooms

Finding: The door closing device at the entrance door limits the vertical headroom clearance to less than 80 inches in height and protrudes into the primary path of travel.

Full Rec Replace the door closing device with a device that fits above the door casing and does not protrude into the primary path of travel.

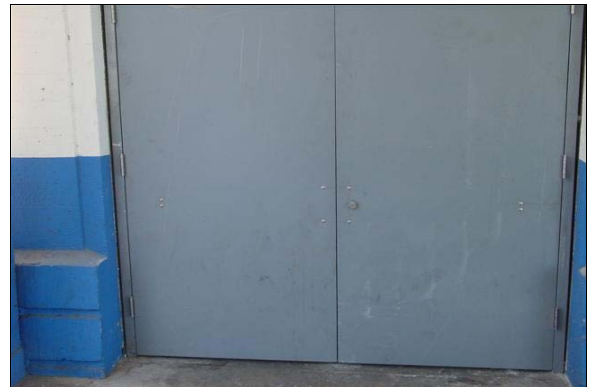
Accessible Route to the Cafeteria

Finding: There is no accessible hardware on the accessible entrance door to the Cafeteria.

Full Rec Provide compliant accessible door hardware (see ADAAG 4.13.9).

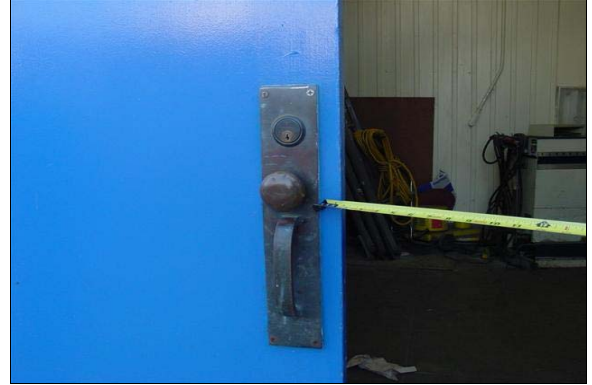
Accessible Route to the Home Economics Restrooms

Finding: The exterior door that provides access to the interior restrooms does not have accessible hardware.

Full Rec Replace the existing door hardware with accessible hardware (see ADAAG 4.13.9).

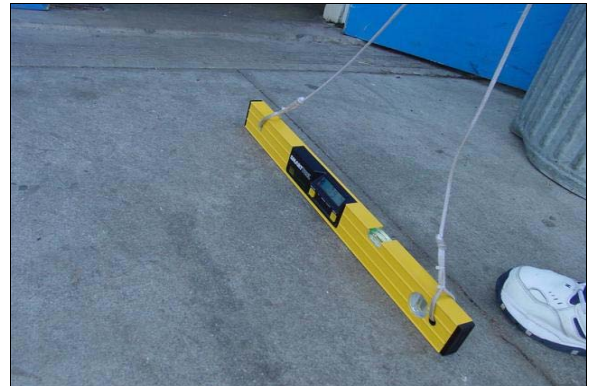
Accessible Route to the Home Economics Restrooms

Finding: There is no level landing provided at the entrance door that provides access to the interior restrooms.

Full Rec Provide a level and clear landing at least 60 inches in length in the direction of the door swing.

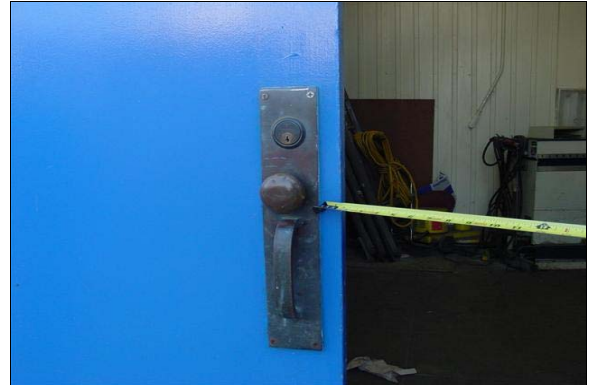
Accessible Route to the Home Economics Restrooms

Finding: The door opening force for the exterior door is greater than 5 pounds of force.

Full Rec Adjust the closers on all exterior doors to a maximum door opening force of 5 pounds of force (see ADAAG 4.13.11 and CBC 1133B.2.5).

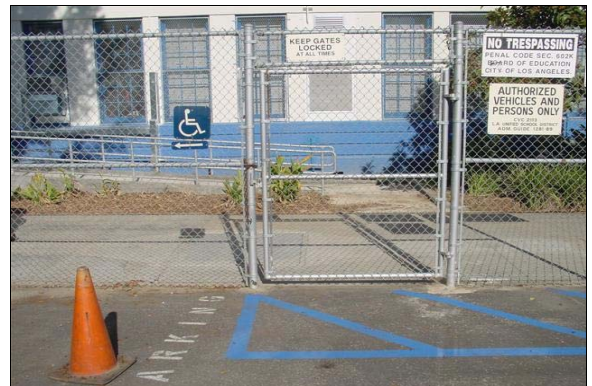
Gate at the Parking Lot

Finding: The bottom 10 inches of the gate, from the parking lot to the facility, does not provide a smooth, uninterrupted surface, or panel to allow the gate to be opened by a wheelchair footrest without creating a trap or hazardous condition.

Full Rec Install a panel or replace the gate to provide a smooth, uninterrupted surface for the bottom 10 inches of the door.

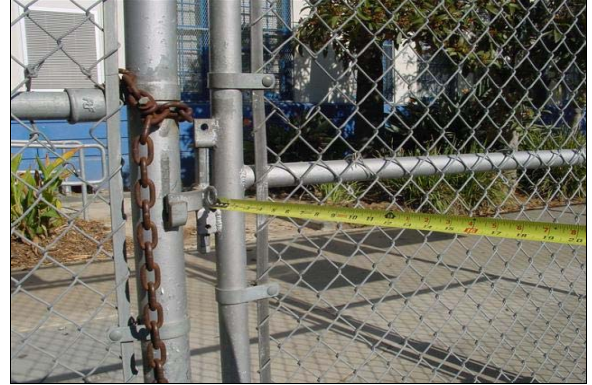
Gate at the Parking Lot

Finding: The gate from the parking lot to the facility does not have accessible hardware.

Full Rec Replace the existing gate hardware with accessible hardware (see ADAAG 4.13.9).

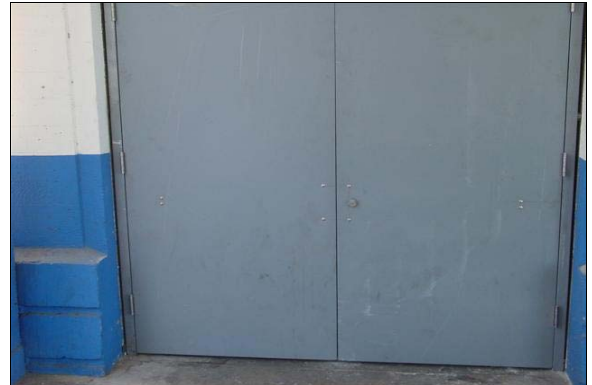
Accessible Entrance to the Cafeteria

Finding: There is no signage with the International Symbol of Accessibility on the entrance door to the cafeteria designating it as accessible.

Full Rec The International Symbol of Accessibility shall be the standard used to identify facilities that are accessible to and usable by physically disabled persons (see CBC 1117B.5.1). All building entrances that are accessible to and usable by persons with disabilities shall be identified with an ISA symbol (see CBC 1117B.5.7).

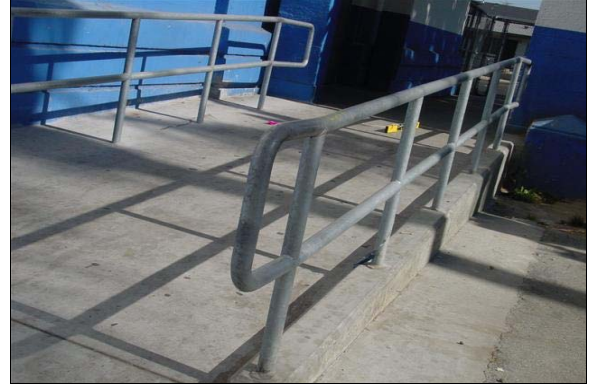
Accessible Route to the Cafeteria

Finding: There is no directional signage to the accessible entrance of the Cafeteria.

Full Rec Install directional signage to each common area complying with CBC 1117B.5 and ADAAG 4.30.

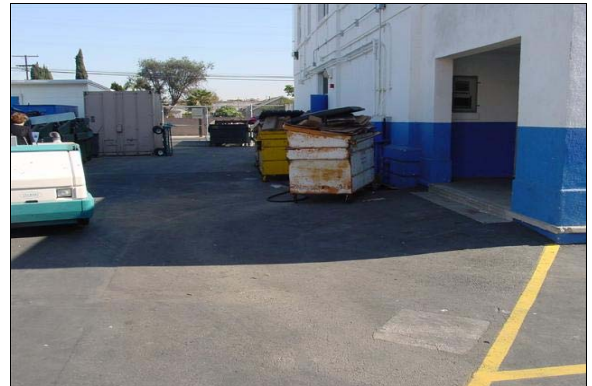
Accessible Route to the Home Economics Restrooms

Finding: There is no directional signage to the accessible entrance or to the accessible restrooms in the Home Economics Building.

Full Rec Install directional signage to each common area complying with CBC 1117B.5 and ADAAG 4.30.

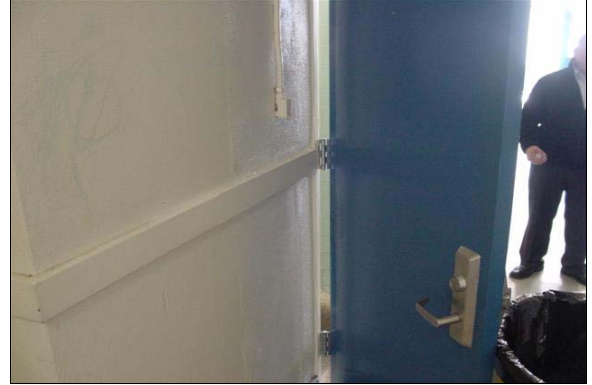
Boys Restroom Across from Room 33 Admin. Building

Finding: There is no signage indicating accessibility on the latch side of the entry door of the restroom. There is no Title 24 gender use signage on the entrance door.

Full Rec Post signage centered 60 inches above the ground surface on the latch side of the entrance door identifying the restroom as accessible. Signage shall include Braille and raised lettering, the gender or unisex use symbol and the ISA symbol. Post Title 24 gender use signage on the door @ 60" o.c. a.f.f.

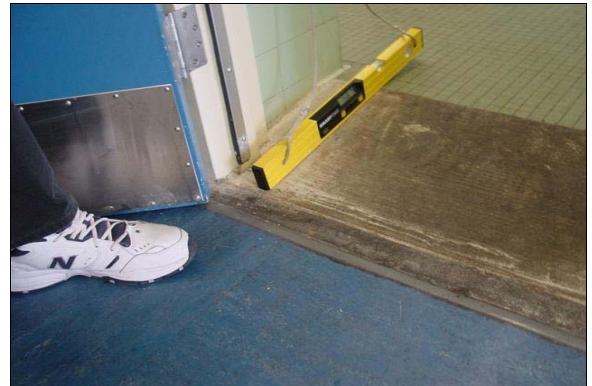
Boys Restroom Across from Room 33 Admin. Building

Finding: There is no level landing provided at the entrance door to the restroom.

Full Rec Provide a level and clear landing at least 60 inches in length in the direction of the door swing.

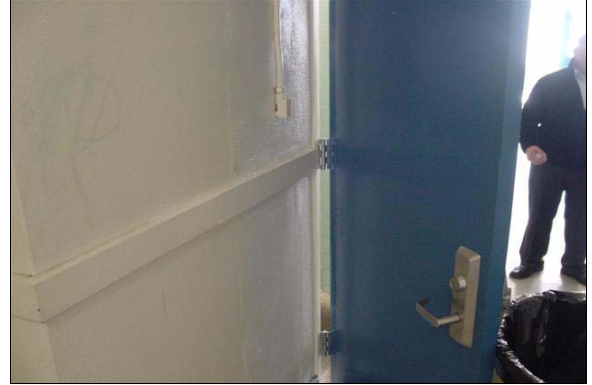
Boys Restroom Across from Room 33 Admin. Building

Finding: There is less than 12 inches of clearance on the latch side of the entrance door to the restroom from the push side.

Full Rec Provide at least 12 inches of latch side clearance at the entrance door to the restroom from the push side (see ADAAG 4.13.6 and Figure 25). Otherwise, install an automatic door opening device to the primary entrance complying with ADAAG 4.13.12 and ANSI/BHMA A156.10, 1985, standards.
