Site Survey of Selected Items
for
Compliance with the Americans with Disabilities Act
(ADAAG)
and
Title 24 of the CBC

The site survey of William Howard Taft High School was conducted on February 26, 2007 during a spot check for compliance with the Americans with Disabilities Act Guidelines (ADAAG) and Title 24 of the CBC

Facility Name: William Howard Taft High School

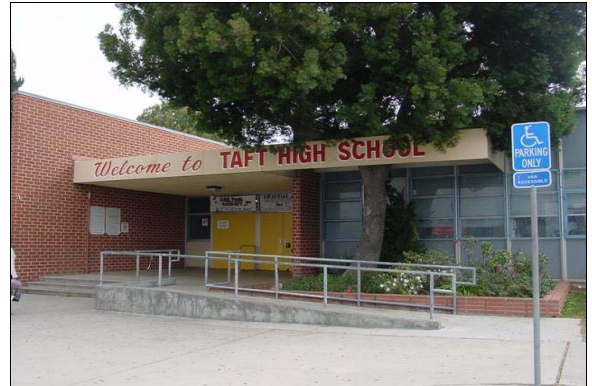
Finding: William Howard Taft High School located at 5461 Winnetka Avenue in Woodland Hills California, provides services to students in Grades 9 thru 12. The facility was inspected by Disability Access Consultants, Inc., on February 26, 2007. This is a report of renovated items and is not intended as a full report.

Full Rec Any renovation or new construction that occurred after January 26, 1992, is subject to meet full code specifications for the California Building Code and ADAAG requirements. All recommendations in this report are based on ADAAG and CBC title 24 requirements. Consult with your design professional to determine which elements are affected by these requirements. It is recommended that Disability Access Consultants, Inc. is consulted for inspection of any new construction or renovation at the facility.

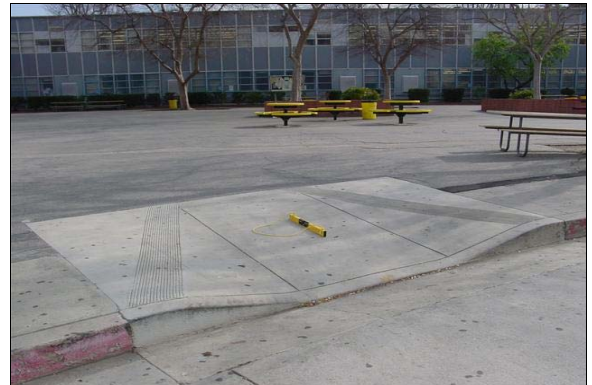
Curb Ramp at West Side of Building C at Service Road

Finding: The slope of the curb ramp is 10.3%. The slope at the top landing is 2.9%. The slope of the bottom landing is 11.7%. The slope of the side flares are greater than 10%. The transition at the bottom landing is abrupt. The curb ramp does not provide a detectable warning surface which includes truncated domes.

Full Rec Replace the curb ramp with a curb ramp at least 48 inches in width that provides a slope no greater than 8.33% and a cross slope no greater than 2%. The slope of the top landing shall not exceed 2% and shall provide at least 48 inches in length of maneuvering clearance. The bottom landing shall provide a smooth transition. The side flares shall be no greater in slope than 10%. Install a detectable warning surface which extends the full length and width of the concrete curb ramp and its side flares with truncated domes that contrast visually by either light on dark or dark on light which is an integral part of the concrete curb ramp.

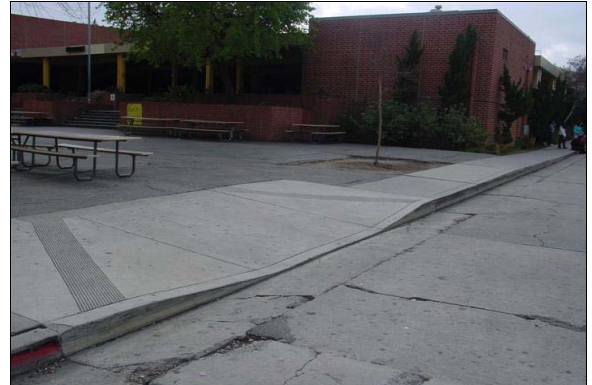
Curb Ramp Northeast of Cafeteria at Service Road

Finding: The slope of the curb ramp is 9.4%. The slope at the top landing is 2.3%. The slope of the right side flare is 10.6%. The transition at the bottom landing is abrupt. The curb ramp does not provide a detectable warning surface which includes truncated domes.

Full Rec Replace the curb ramp with a curb ramp at least 48 inches in width that provides a slope no greater than 8.33% and a cross slope no greater than 2%. The slope of the top landing shall not exceed 2% and shall provide at least 48 inches in length of maneuvering clearance. The bottom landing shall provide a smooth transition. The side flares shall be no greater in slope than 10%. Install a detectable warning surface which extends the full length and width of the concrete curb ramp and its side flares with truncated domes that contrast visually by either light on dark or dark on light which is an integral part of the concrete curb ramp.

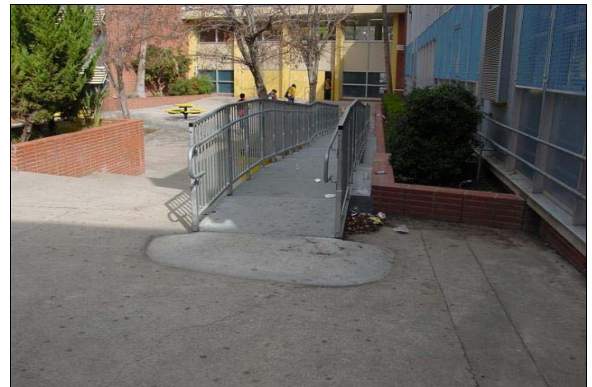
Ramp on North Side of Building D

Finding: The length of the second intermediate landing on the ramp is 48 inches.

Full Rec Modify or replace the intermediate landing on the ramp to provide at least 60 inches in length in the direction of the run of the ramp and 48 inches in width (see CBC 1133B.5.4.6 and ADAAG 4.8.4).

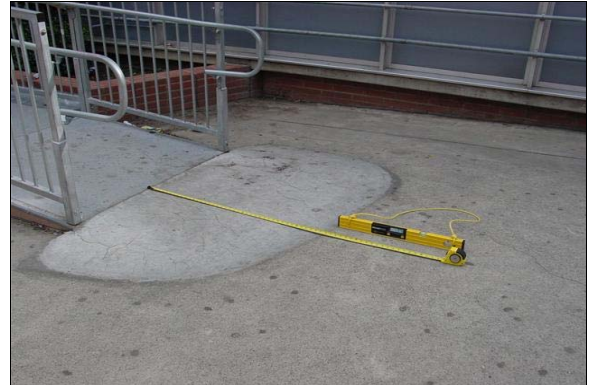
Ramp on North Side of Building D

Finding: The slope of the top landing is 4.7%.

Full Rec Modify or replace the top landing on the ramp to provide a top landing that exceeds 60 inches in length and 60 inches in width with a level surface that does not exceed a slope greater than 2%.

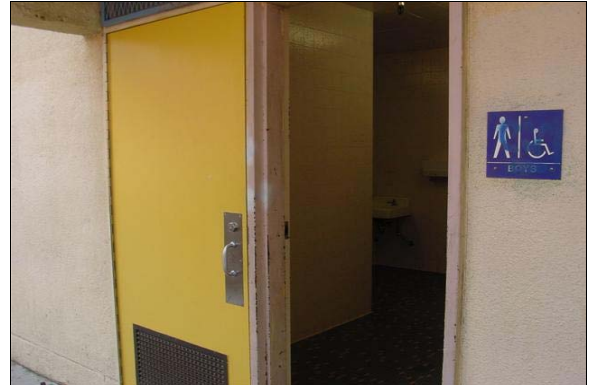
Boys Restroom Building M

Finding: There is signage indicating accessibility on the entry door to the restroom. The signage is centered 60 inches above the floor on the latch side of the entrance door and includes Braille and raised lettering, gender use symbol and the ISA symbol.

Full Rec The restroom is designated accessible and should be made an accessible restroom for the facility. Monitor signage for continued compliance with CBC 1115B.5, ADAAG 4.1.2(7) and ADAAG 4.1.6(3)(e) and ADAAG 4.30.

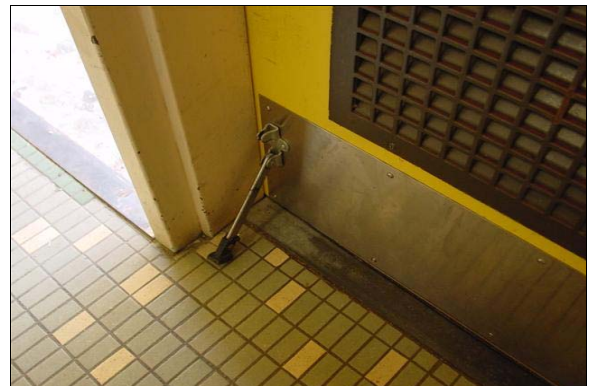
Boys Restroom Building M

Finding: The bottom 10 inches of the door does not provide a smooth, uninterrupted surface, or panel to allow the door to be opened by a wheelchair footrest without creating a trap or hazardous condition, due to a doorstop.

Full Rec Remove the doorstop from the door to provide a smooth, uninterrupted surface for the bottom 10 inches of the door.

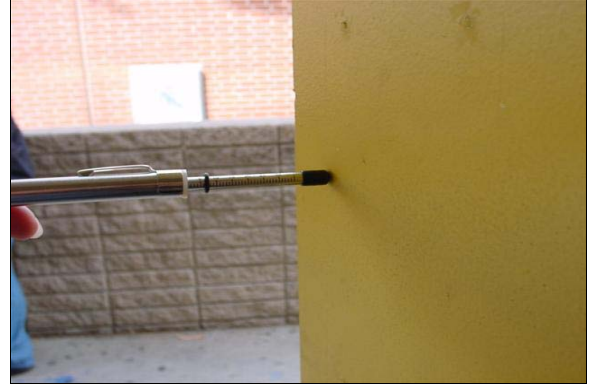
Boys Restroom Building M

Finding: The door opening force for the entrance door to the restroom is 6.5 pounds.

Full Rec Adjust the closer on the entrance door to the restroom to a maximum door opening force of 5 pounds.

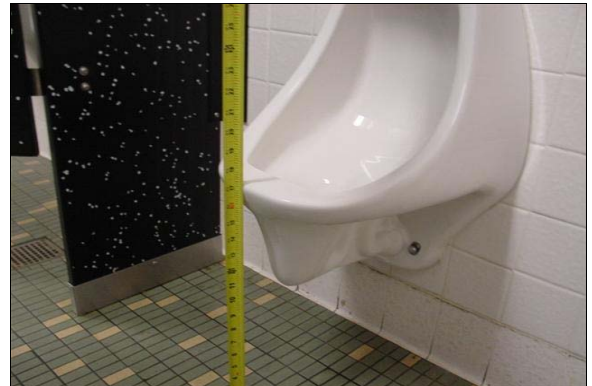
Boys Restroom Building M

Finding: The height of the urinal rim in the restroom is 17 1/4 inches above the finished floor.

Full Rec Lower the urinal designated to be accessible in the restroom so that the rim height is not more than 17 inches above the finished floor.

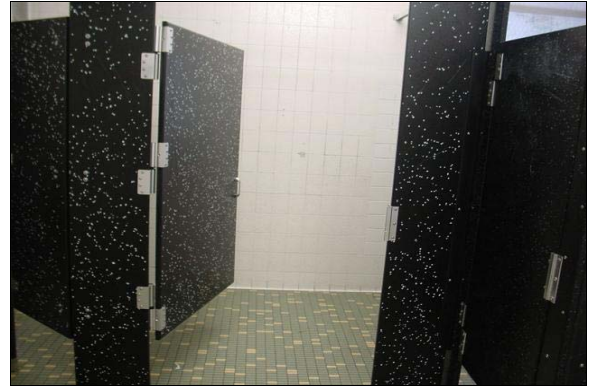
Boys Restroom Building M

Finding: The stall door to the stall designated to be accessible in the restroom swings inward limiting the clear floor space in the stall designated to be accessible.

Full Rec Modify the swing of the door on the stall designated to be accessible in the restroom so that it does not limit clear floor space in the stall.

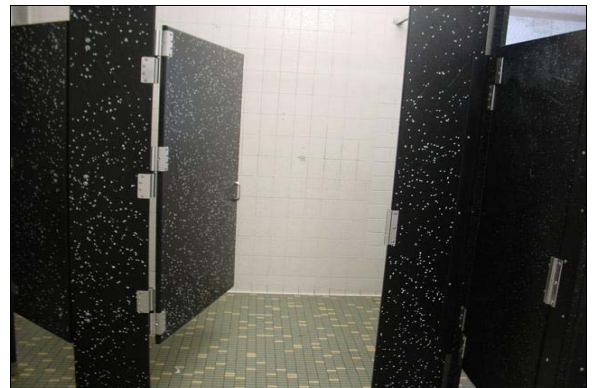
Boys Restroom Building M

Finding: The door to the stall designated to be accessible in the restroom does not close automatically or have accessible hardware.

Full Rec Provide an automatic door closer, spring hinge, pull bar or accessible handle mounted on the inside of the stall door to the stall designated to be accessible in the restroom (see ADAAG A4.17.5). Accessible hardware on the inside and outside of the stall designated to be accessible door shall be equipped with a loop or U-shaped handle mounted immediately below the latch. The latch shall be flip-over style, sliding or other hardware not requiring grasping or twisting. Make certain that the inside and outside door hardware is mounted no more than 48 inches above the finished floor (see CBC 115B.7.1.3 and ADAAG 4.13.9).

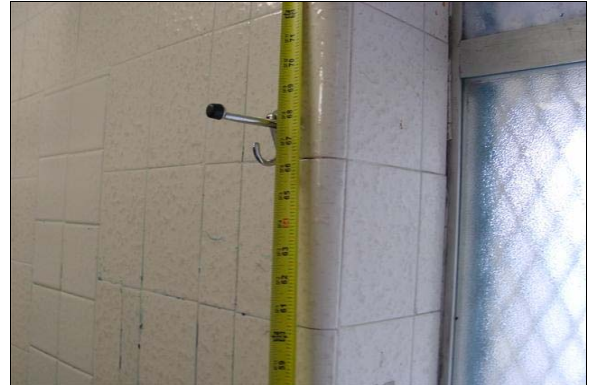
Boys Restroom Building M

Finding: The height of the coat hook is 66 1/2 inches above the finished floor.

Full Rec Relocate the coat hook to a height no greater than 48 inches above the finished floor.

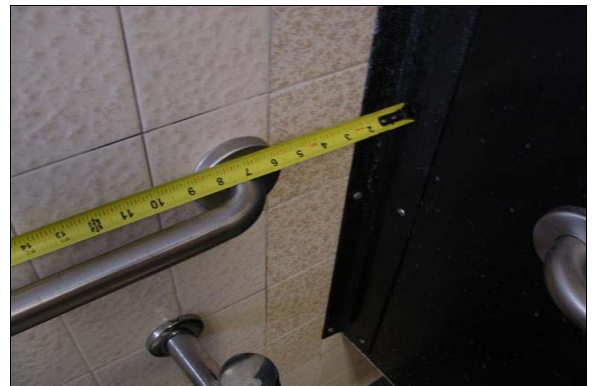
Boys Restroom Building M

Finding: The side grab bar is centered at 33 1/2 inches above the finished floor, and the back grab bar is centered at 32 5/8 inches above the finished floor. The distance from the end of the back grab bar to the nearest side wall is 7 inches.

Full Rec Remount the side and back grab bar in the stall designated to be accessible in the restroom so that the height of the gripping surface is centered at 33 inches above finished floor. The back grab bar shall be not more than 6 inches from the nearest side wall. Grab bars must be able to support a point load of at least 250 pounds and shall be less than the allowable shear stress of the grab bar material.

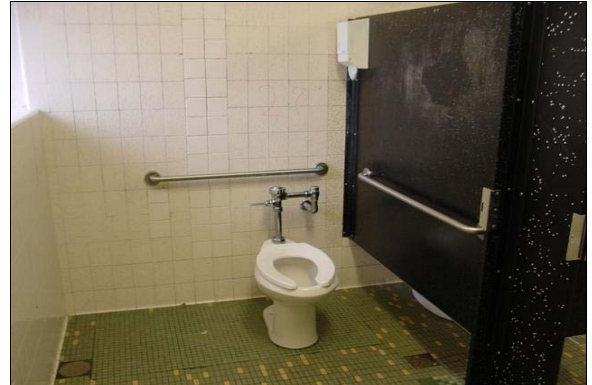
Boys Restroom Building M

Finding: The location of the toilet paper dispenser in the stall designated to be accessible in the restroom is not within 12 inches of the front edge of the toilet seat.

Full Rec Remount the toilet paper dispenser in the stall designated to be accessible in the restroom so that it is within 12 inches from the front edge of the toilet seat (see CBC 1115B.9.3 and ADAAG Figure 29(b)). Toilet paper dispensers must allow continuous paper flow and shall not interfere with the use of the side grab bar.

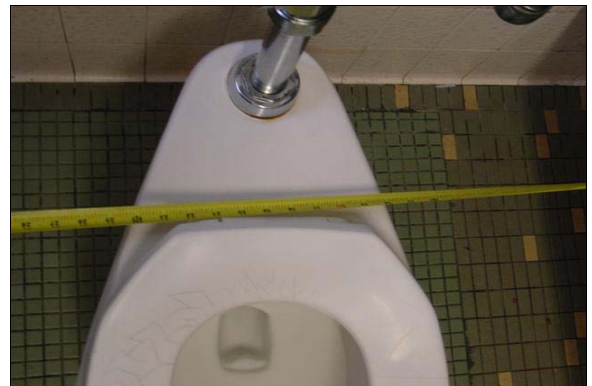
Boys Restroom Building M

Finding: The distance from the center of the toilet to the nearest side wall in the stall designated to be accessible in the restroom is 18 3/4 inches.

Full Rec Relocate the toilet or stall side wall so that the distance from the centerline of the toilet to the nearest side wall in the stall designated to be accessible in the restroom is exactly 18 inches (see ADAAG Figure 28).

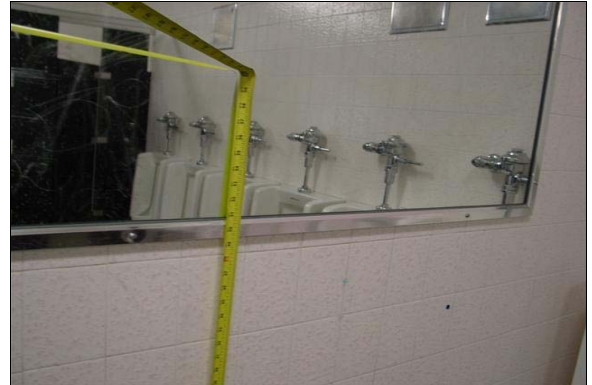
Boys Restroom Building M

Finding: The bottom edge of the reflecting surface of the mirror in the restroom is 50 5/8 inches above the finished floor.

Full Rec Lower the mirror in the restroom so that the bottom edge of the reflecting surface is no higher than 40 inches above the finished floor and the topmost portion of the reflecting surface extends at least 74 inches above the finished floor (see ADAAG A4.19.6). A single, full-length mirror is recommended since it can accommodate all people. Make certain to provide a minimum clear floor space in front of the mirror of 30 inches in width and 48 inches in length.

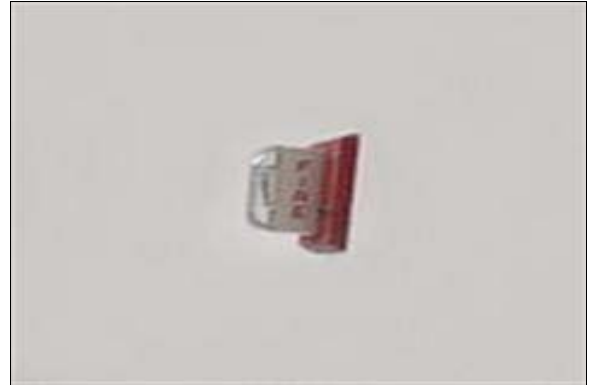
Finding: There are no visual warning devices in common areas of the facility.

Full Rec Install visual warning devices integrated with the facility's alarm system complying with CBC 1114B.2.5, ADAAG 4.1.3(14) and ADAAG 4.28 in all common areas such as hallways, general use rooms, and in accessible restrooms and other accessible rooms.
