Site Survey of Selected Items
for
Compliance with the Americans with Disabilities Act
(ADAAG)
and
Title 24 of the CBC

The site survey of Peary Middle School was conducted on November 30, 2006 during a spot check for compliance with the Americans with Disabilities Act Guidelines (ADAAG) and Title 24 of the CBC

Facility Name: Robert Peary Middle School

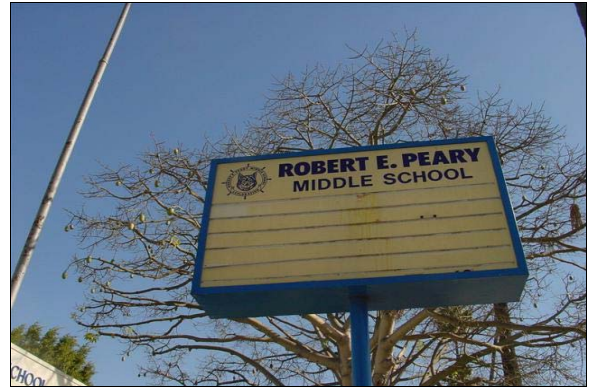
Finding: Robert Peary Middle School is located at 1415 West Gardena Boulevard in Gardena California. The facility was inspected by Disability Access Consultants, Inc., on November 30, 2006. This is a report of selected items and is not intended as a full report.

Full Rec Any renovation or new construction that occurred after January 26, 1992, is subject to meet full code specifications for the California Building Code and ADAAG requirements. All recommendations in this report are based on ADAAG and CBC Title 24 requirements. Consult with your design professional to determine which elements are affected by these requirements. It is recommended that Disability Access Consultants, Inc. is consulted for inspection of any new construction or renovation at the facility.

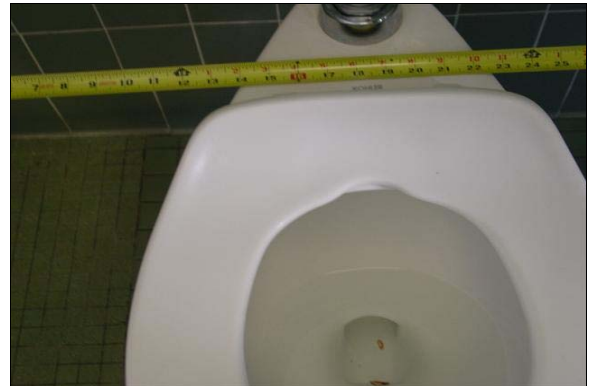
Boys Restroom Across from Room 33 Admin. Building

Finding: The distance from the center of the toilet to the nearest side wall is 18 3/8 inches.

Full Rec Relocate the toilet so that the distance from the centerline of the toilet to the nearest side wall is exactly 18 inches (see ADAAG Figure 28).

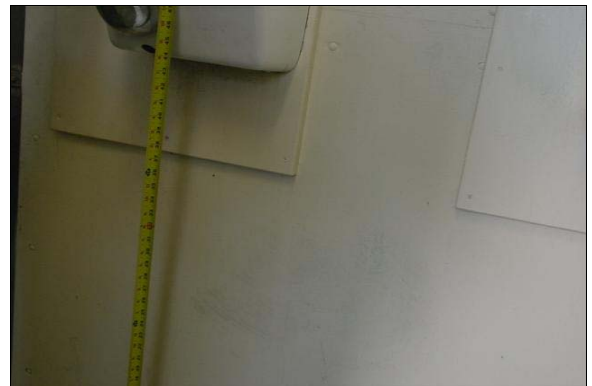
Boys Restroom Across from Room 33 Admin. Building

Finding: The height of the controls and operating mechanisms for the hand dryer is greater than 40 inches in height.

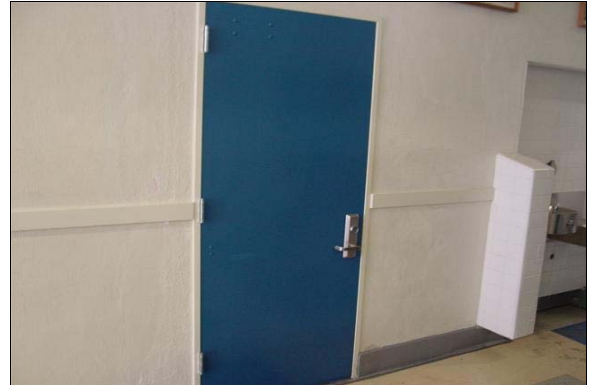
Girls Restroom Across from Room 25 Admin. Building

Finding: There is no signage indicating accessibility on the latch side of the entry door of the restroom. There is no Title 24 gender use signage on the entrance door.

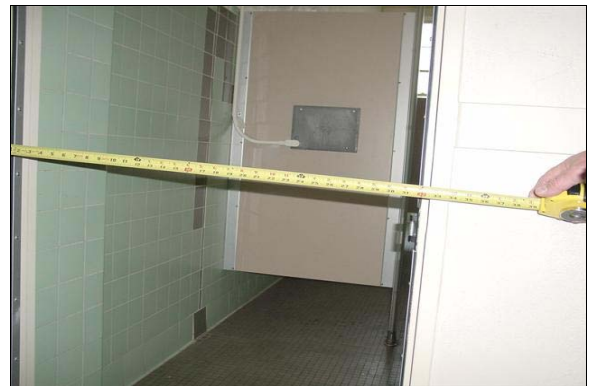
Girls Restroom Across from Room 25 Admin. Building

Finding: The clear opening width of the entrance doorway to the restroom is less than 32 inches.

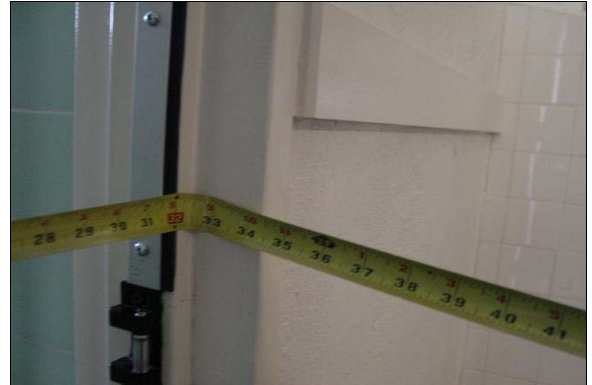
Girls Restroom Across from Room 25 Admin. Building

Finding: There is less than 12 inches of clearance on the latch side of the entrance door to the restroom from the push side.

Full Rec Provide at least 12 inches of latch side clearance at the entrance door to the restroom from the push side (see ADAAG 4.13.6 and Figure 25). Otherwise, install an automatic door opening device to the primary entrance complying with ADAAG 4.13.12 and ANSI/BHMA A156.10, 1985, standards.

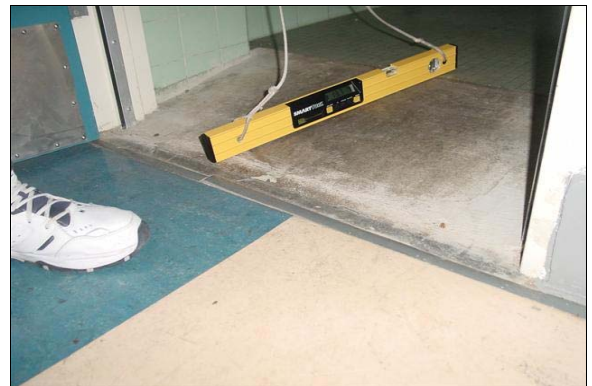
Girls Restroom Across from Room 25 Admin. Building

Finding: There is no level landing provided at the entrance door.

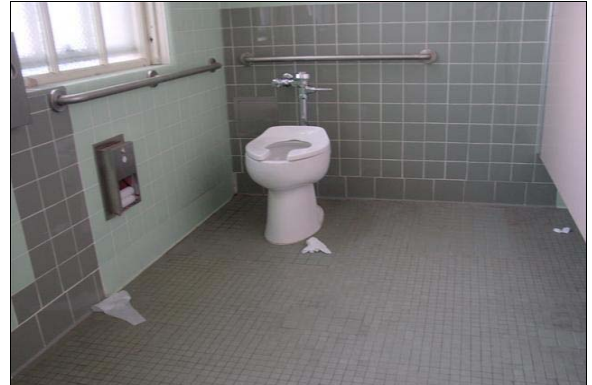
Girls Restroom Across from Room 25 Admin. Building

Finding: The location of the toilet paper dispenser is not within 12 inches of the front edge of the toilet.

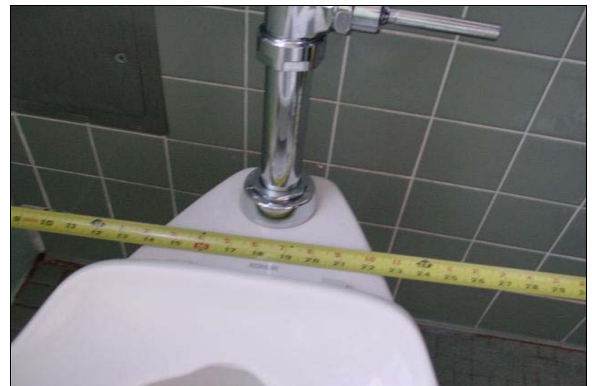
Girls Restroom Across from Room 25 Admin. Building

Finding: The distance from the center of the toilet to the nearest side wall is 18 3/8 inches.

Full Rec Relocate the toilet so that the distance from the centerline of the toilet to the nearest side wall is exactly 18 inches (see ADAAG Figure 28).

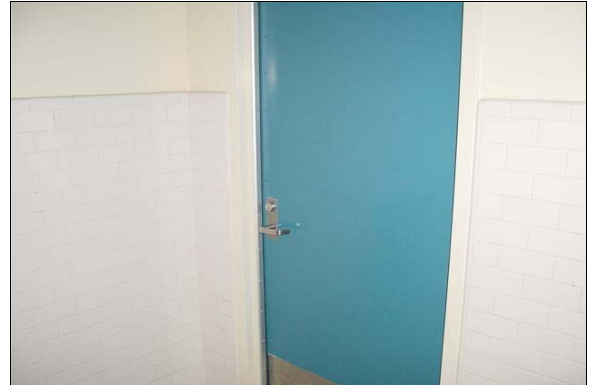
Girls Restroom first floor Home Economics Bldg.

Finding: There is no signage indicating accessibility on the latch side of the entry door of the restroom. There is no Title 24 gender use signage on the entrance door.

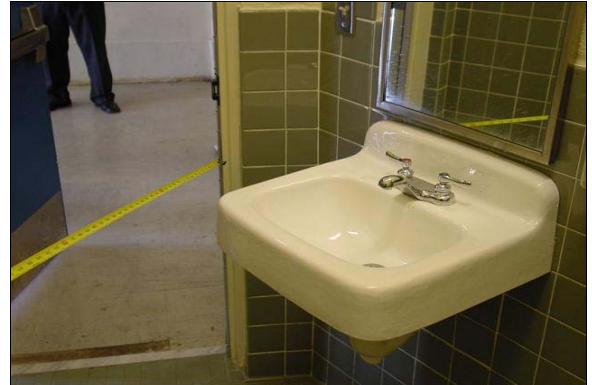
Staff Mens Restroom First Floor Administration Building

Finding: There is less than 12 inches of clearance on the latch side of the entrance door to the restroom from the push side.

Full Rec Provide at least 12 inches of latch side clearance at the entrance door to the restroom from the push side (see ADAAG 4.13.6 and Figure 25). Otherwise, install an automatic door opening device to the primary entrance complying with ADAAG 4.13.12 and ANSI/BHMA A156.10, 1985, standards.

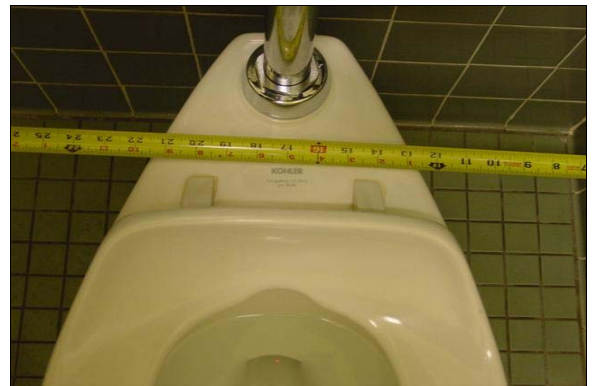
Staff Mens Restroom First Floor Administration Building

Finding: The distance from the center of the toilet to the nearest side wall in is 17 inches.

Full Rec Relocate the toilet so that the distance from the centerline of the toilet to the nearest side wall is exactly 18 inches (see ADAAG Figure 28).

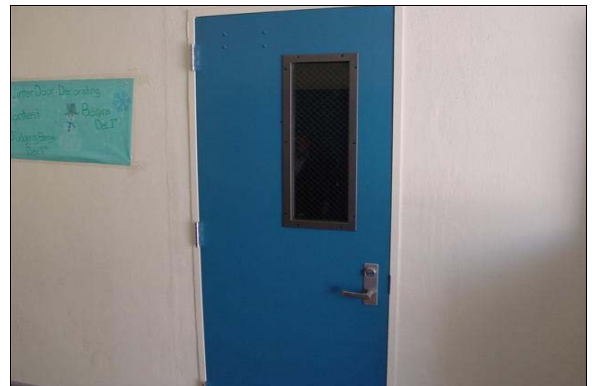
Staff Unisex Restroom Second Floor Administration Building

Finding: There is a hallway door on the second floor next to room 33 than leads to the accessible staff unisex restroom. There is no directional signage posted to the accessible restroom.

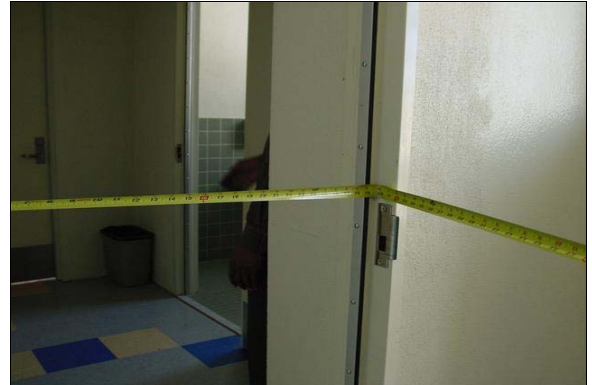
Staff Unisex Restroom Second Floor Administration Building

Finding: The clear opening width of the hallway entrance door that leads to the staff unisex restroom is less than 32 inches.

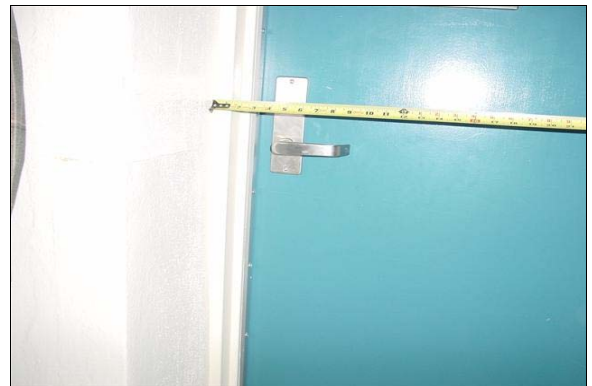
Staff Unisex Restroom Second Floor Administration Building

Finding: There is less than 12 inches of clearance on the latch side of the hallway entrance door that leads to the staff unisex restroom, from the push side.

Full Rec Provide at least 12 inches of latch side clearance at the entrance door to the restroom from the push side (see ADAAG 4.13.6 and Figure 25). Otherwise, install an automatic door opening device to the primary entrance complying with ADAAG 4.13.12 and ANSI/BHMA A156.10, 1985, standards.

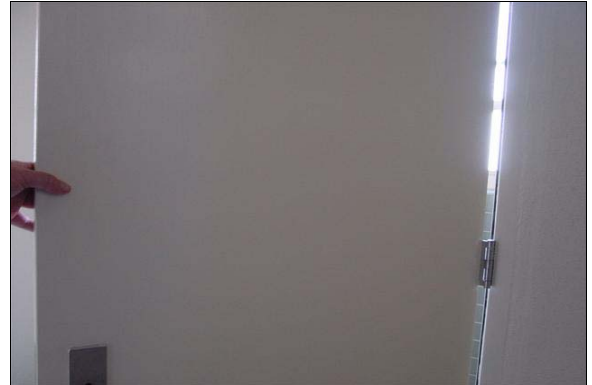
Staff Unisex Restroom Second Floor Administration Building

Finding: There is no signage indicating accessibility on the latch side of the entry door of the restroom. There is no Title 24 gender use signage on the entrance door.

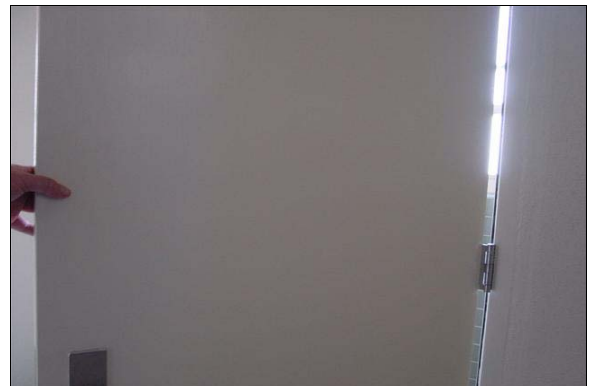
Staff Unisex Restroom Second Floor Administration Building

Finding: There is no accessible lock on the unisex restroom door.

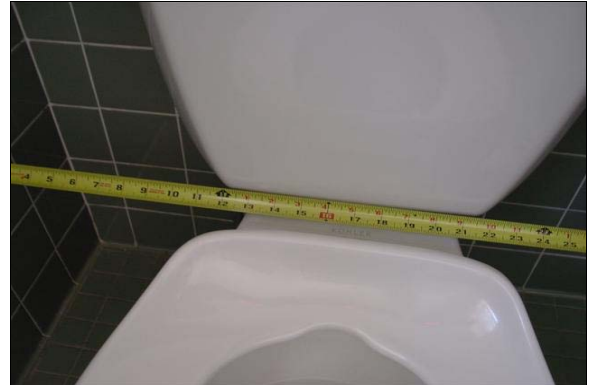
Staff Unisex Restroom Second Floor Administration Building

Finding: The distance from the center of the toilet to the nearest side wall is 16 7/8 inches.

Full Rec Relocate the toilet so that the distance from the centerline of the toilet to the nearest side wall is exactly 18 inches (see ADAAG Figure 28).

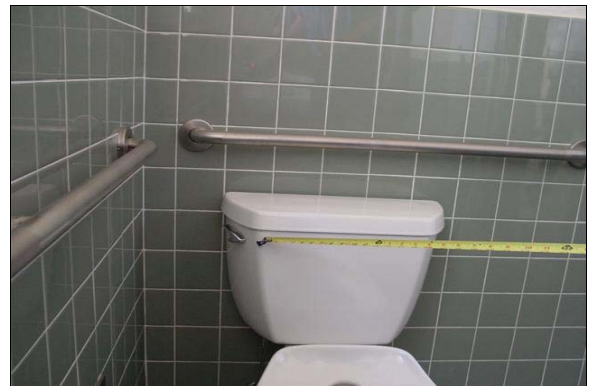
Staff Unisex Restroom Second Floor Administration Building

Finding: The flush control on the toilet is not on the wide (approach) side of the toilet.

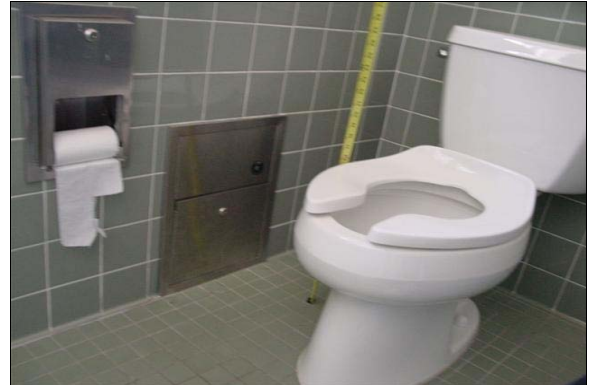
Staff Unisex Restroom Second Floor Administration Building

Finding: The height of the toilet seat is 15 1/2 inches above the finished floor.

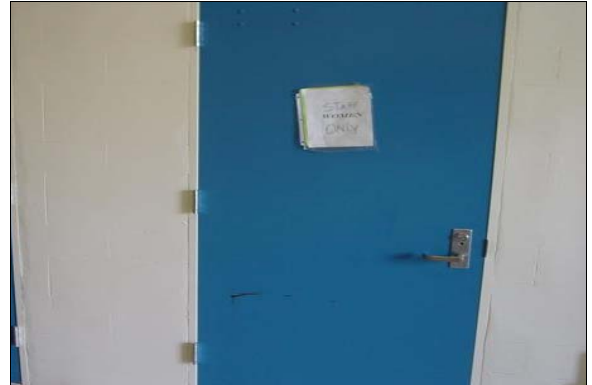
Staff Womens Restroom First Floor Administration Building

Finding: There is no signage indicating accessibility on the latch side of the entry door of the restroom. There is no Title 24 gender use signage on the entrance door.

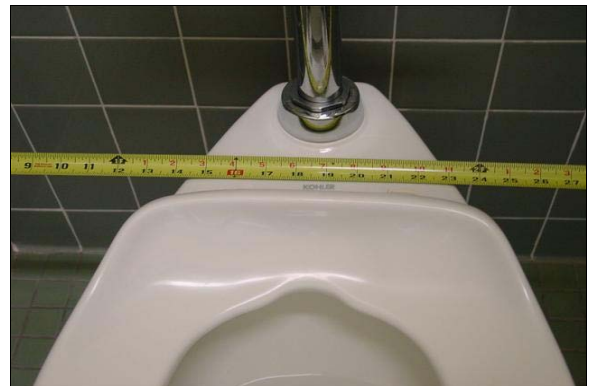
Staff Womens Restroom First Floor Administration Building

Finding: The distance from the center of the toilet to the nearest side wall is 18 3/4 inches.

Full Rec Relocate the toilet so that the distance from the centerline of the toilet to the nearest side wall is exactly 18 inches (see ADAAG Figure 28).

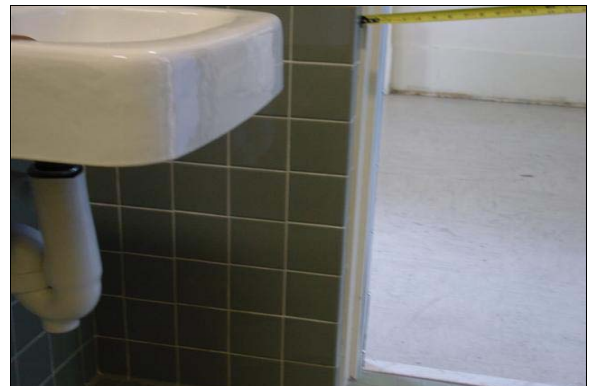
Staff Womens Restroom First Floor Administration Building

Finding: There is less than 12 inches of clearance on the latch side of the entrance door to the restroom from the push side.

Full Rec Provide at least 12 inches of latch side clearance at the entrance door to the restroom from the push side (see ADAAG 4.13.6 and Figure 25). Otherwise, install an automatic door opening device to the primary entrance complying with ADAAG 4.13.12 and ANSI/BHMA A156.10, 1985, standards.

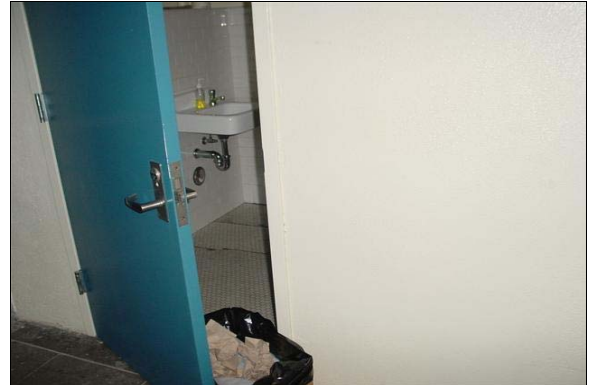
Staff Womens Restroom first floor Home Economics Bldg.

Finding: There is no signage indicating accessibility on the latch side of the entry door of the restroom. There is no Title 24 gender use signage on the entrance door.

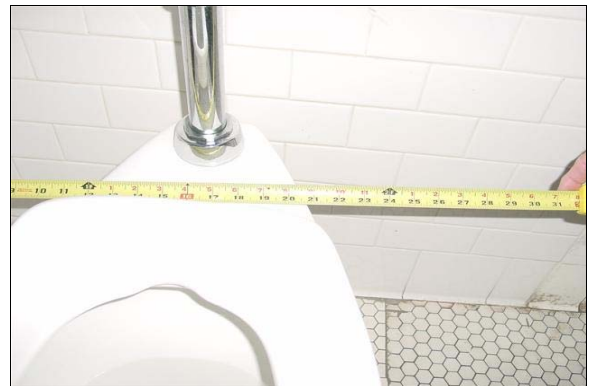
Staff Womens Restroom first floor Home Economics Bldg.

Finding: The distance from the center of the toilet to the nearest side wall is 16 1/2 inches.

Full Rec Relocate the toilet so that the distance from the centerline of the toilet to the nearest side wall is exactly 18 inches (see ADAAG Figure 28).

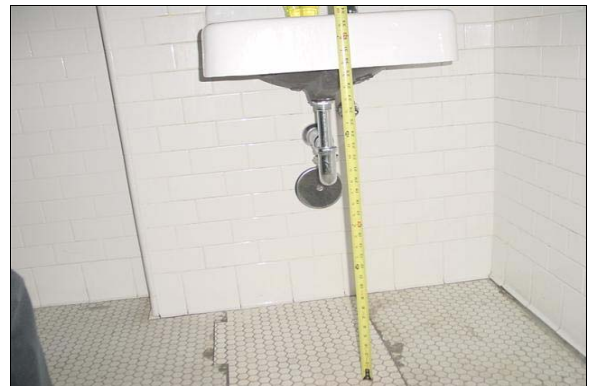
Staff Womens Restroom first floor Home Economics Bldg.

Finding: The pipes under the lavatory in the restroom do not provide protection against contact.

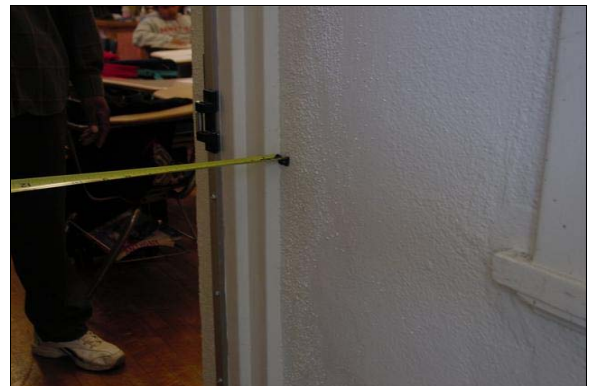
Student Unisex Restroom in Room 52 Home Ec. Bldg

Finding: There is less than 12 inches of clearance on the latch side of the entrance door to the restroom from the push side.

Full Rec Provide at least 12 inches of latch side clearance at the entrance door to the restroom from the push side (see ADAAG 4.13.6 and Figure 25). Otherwise, install an automatic door opening device to the primary entrance complying with ADAAG 4.13.12 and ANSI/BHMA A156.10, 1985, standards.

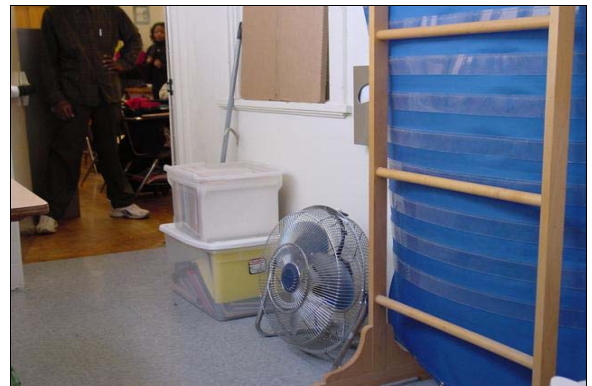
Student Unisex Restroom in Room 52 Home Ec. Bldg

Finding: At the time of inspection the restroom was used for storage and did not provide the minimum clear floor space required for a wheelchair turning radius.

Full Rec Accessible restroom must provide sufficient clear floor space to inscribe a 60-inch diameter turning radius in the restroom.

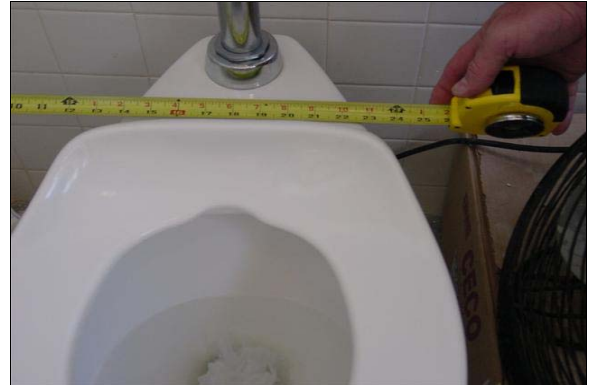
Student Unisex Restroom in Room 52 Home Ec. Bldg

Finding: The distance from the center of the lavatory to the adjacent side wall is less than 17 1/4 inches.

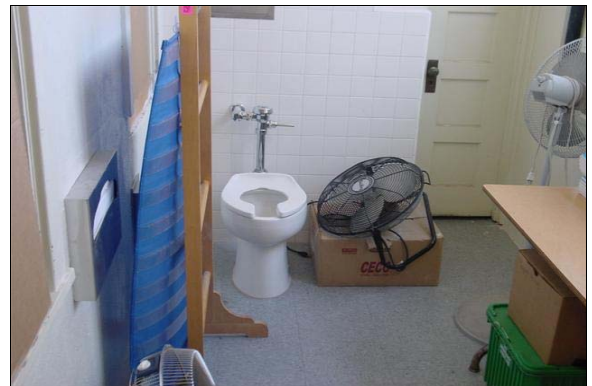
Student Unisex Restroom in Room 52 Home Ec. Bldg

Finding: There are no grab bars in the restroom.

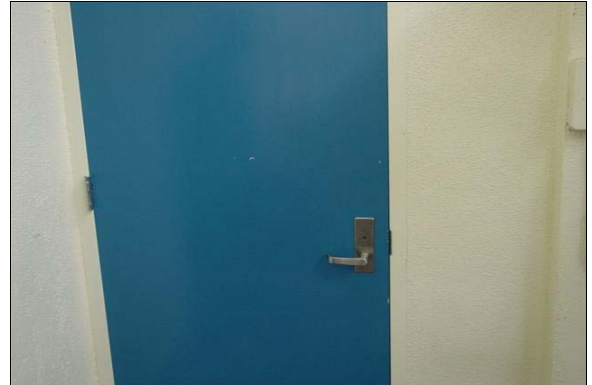
Unisex Restroom in Shop Building Room 61

Finding: There is no signage indicating accessibility on the latch side of the entry door of the restroom. There is no Title 24 gender use signage on the entrance door.

Full Rec Post signage centered 60 inches above the ground surface on the latch side of the entrance door identifying the restroom as accessible. Signage shall include Braille and raised lettering, the gender or unisex use symbol and the ISA symbol. Post Title 24 gender use signage on the door @ 60" o.c. a.f.f.

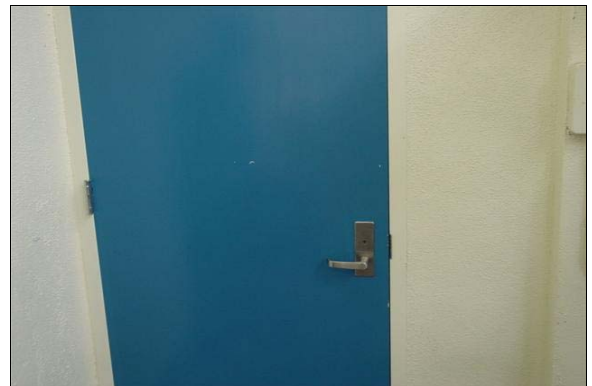
Unisex Restroom in Shop Building Room 61

Finding: There is no accessible lock on the unisex restroom door.

Full Rec Provide accessible locking door hardware that displays the word OCCUPIED on the unisex restroom door.

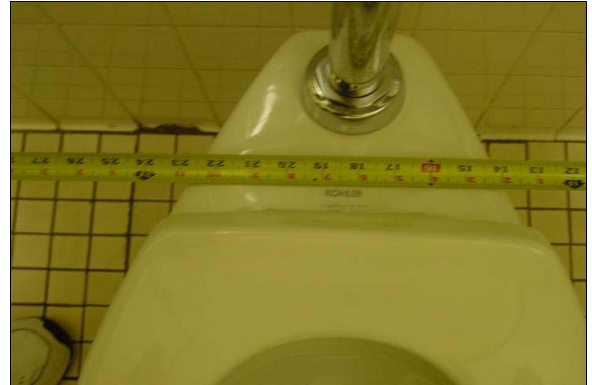
Unisex Restroom in Shop Building Room 61

Finding: The distance from the center of the toilet to the nearest side wall is 18 3/8 inches.

Full Rec Relocate the toilet so that the distance from the centerline of the toilet to the nearest side wall is exactly 18 inches (see ADAAG Figure 28).

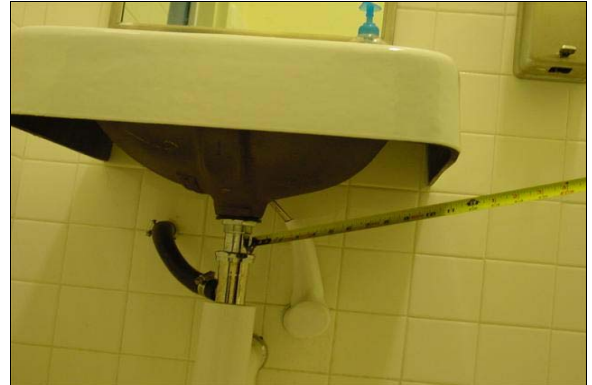
Unisex Restroom in Shop Building Room 61

Finding: All of the pipes under the lavatory do not provide protection against contact.

Full Rec Insulate or otherwise configure pipes under the lavatory to protect against contact (see ADAAG 4.19.4). Make certain there are no sharp or abrasive surfaces under the lavatory.

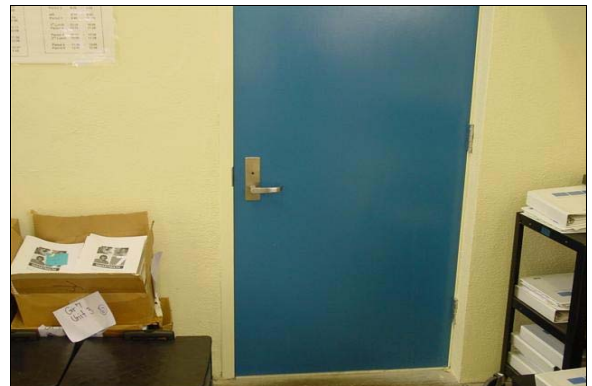
Unisex Restroom in Shop Building Room 62

Finding: There is no signage indicating accessibility on the latch side of the entry door of the restroom. There is no Title 24 gender use signage on the entrance door.

Full Rec Post signage centered 60 inches above the ground surface on the latch side of the entrance door identifying the restroom as accessible. Signage shall include Braille and raised lettering, the gender or unisex use symbol and the ISA symbol. Post Title 24 gender use signage on the door @ 60" o.c. a.f.f.

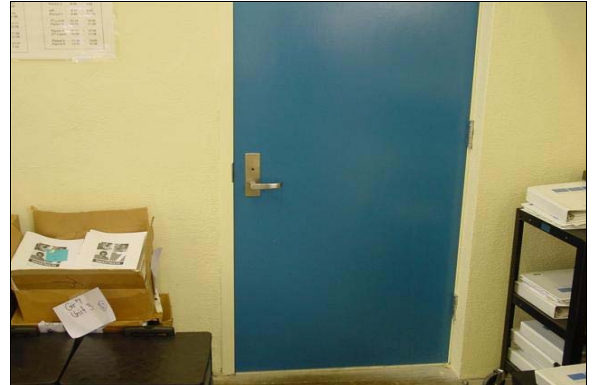
Unisex Restroom in Shop Building Room 62

Finding: There is no accessible lock on the unisex restroom door.

Full Rec Provide accessible locking door hardware that displays the word OCCUPIED on the unisex restroom door.

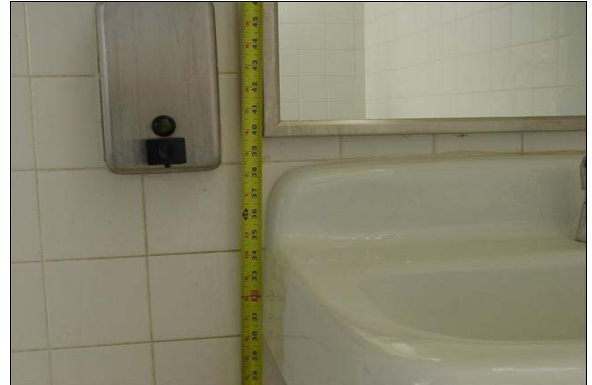
Unisex Restroom in Shop Building Room 62

Finding: The bottom edge of the reflecting surface of the mirror is 40 1/2 inches above the finished floor.

Full Rec Lower the mirror so the bottom edge of the reflecting surface is no higher than 40 inches above the finished floor and the topmost portion of the reflecting surface extends at least 74 inches above the finished floor (see ADAAG A4.19.6). A single, full-length mirror is recommended since it can accommodate all people. Make certain to provide a minimum clear floor space in front of the mirror of 30 inches in width and 48 inches in length.

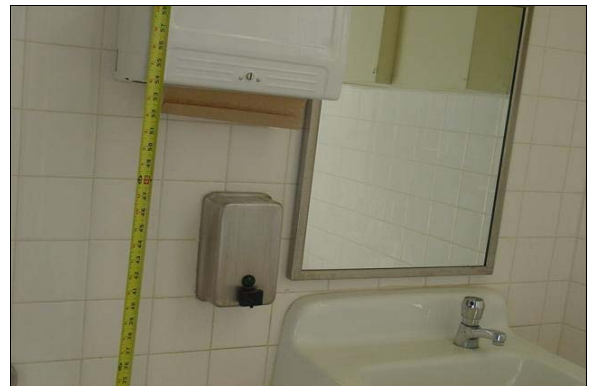
Unisex Restroom in Shop Building Room 62

Finding: The height of the controls and operating mechanisms for the paper towel dispenser is greater than 40 inches in height.

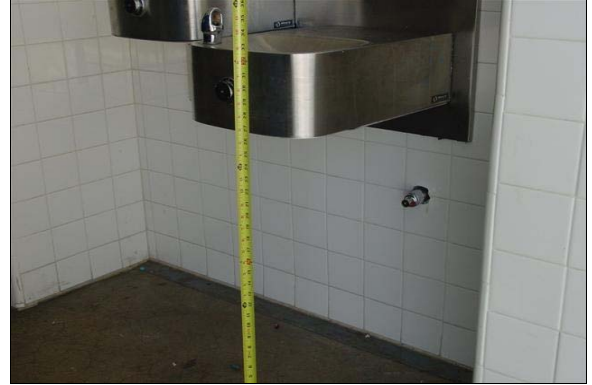
Drinking Fountain Second floor Administration Building

Finding: There is a hi-low fountain located next to Room 33 on the second floor of the Administration Building. There is less than 27 inches knee clearance height at the low side fountain.

Full Rec Provide a minimum knee clearance height of 27 inches at the low side fountain.

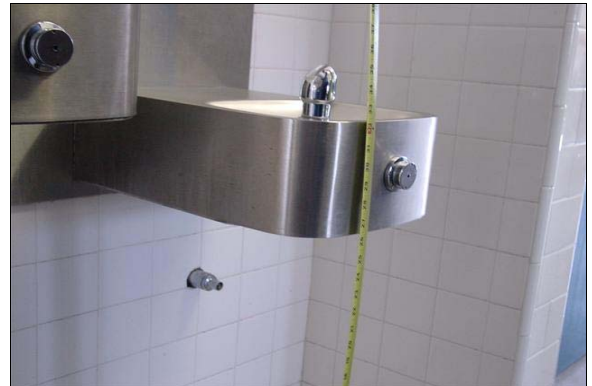
Drinking Fountain Second floor Home Economics Building

Finding: There is a hi-low fountain located across from Room 53 on the second floor of the Home Economics Building. There is less than 27 inches knee clearance height at the low side fountain.

Full Rec Provide a minimum knee clearance height of 27 inches at the low side fountain.
